**LEAPING WELL RESERVOIR
MA 00586**

**PHASE I INSPECTION REPORT
NATIONAL DAM INSPECTION PROGRAM**

JUNE 1981

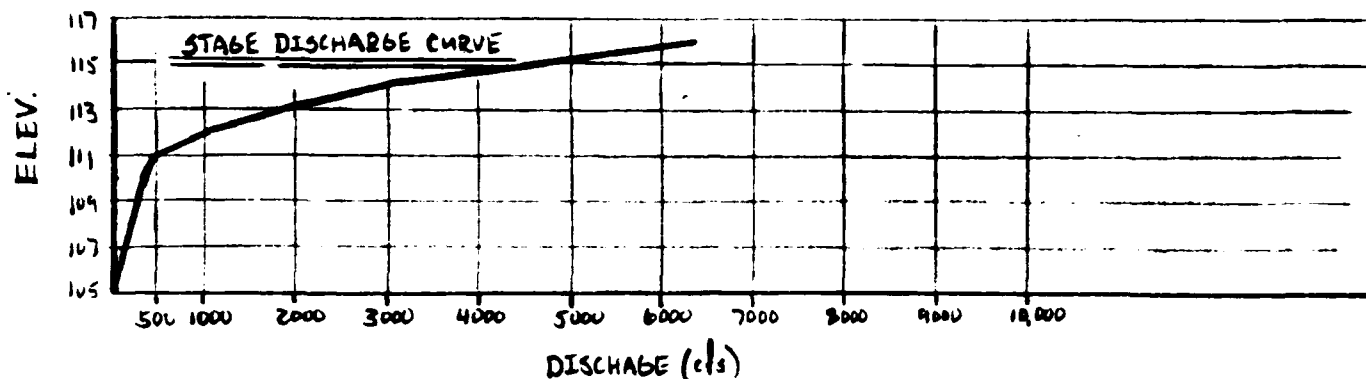
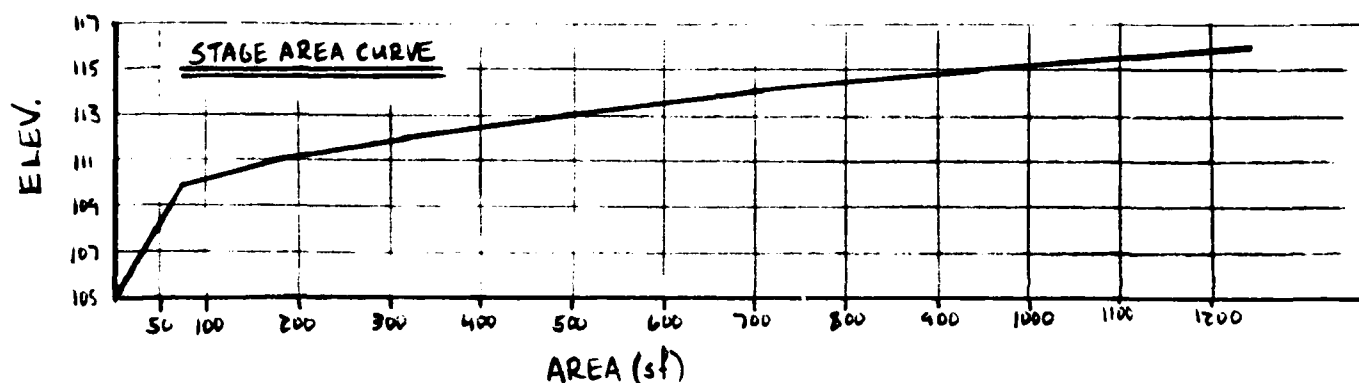
VI. Downstream Dam Failure Analysis : cont.

© $Q_{P4} = 4589 \text{ cfs}$
 $H_1 = 10.1 \text{ ft.} \pm (\text{El. } 115.1 \pm)$
 $V_1 = \frac{730+960}{2} \times 2900 \times \frac{1}{43500} = 56.2 \text{ Ac. Ft.} < \frac{1}{2} S \therefore \text{Reach is OK}$

$\therefore Q_{P5} (\text{TRIAL}) = Q_{P4} (1 - \frac{V_1}{S}) = 4589 (1 - \frac{56.2}{144}) = 2797 \text{ cfs}$
